World Conference on Transport Research - WCTR 2019 Mumbai 26-31 May 2019

## Identifying Critical Safety Issues on Two-Lane National Highways in India – A Case Study from NH 117 and NH 60

*Keywords:* accident risk factors; Road Safety Audit; two-lane highways; countermeasures

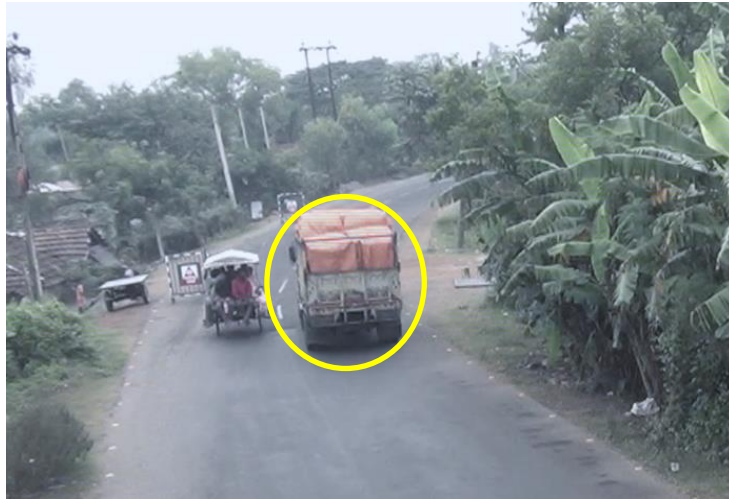
Horizontal curves were found to be the most accident-prone locations along both the highways. Frequent head on conflicts were observed on the horizontal curves. In some curves the lateral shift of vehicles was quite high. The

RSA team noticed that most of the curves lacked sufficient sight distance, primarily due to inadequate set back distance. Further, even in absence of adequate sight distance the vehicles tend to overtake along such curves (Fig. 2). The curves situated in built up areas had frequent pedestrian and NMT interactions which were assessed as more hazardous as the severity outcome at such curves will be higher

Fig. 2. Vehicle overtaking at horizontal curve

Sl.	Risk Element	Risk factors	Proposed Countermeasures
1	Horizontal Curves	<ul style="list-style-type: none"> <li>• Restricted sight distance</li> <li>• Vehicles overtaking at blind curves</li> <li>• Inadequate superelevation</li> </ul>	<ul style="list-style-type: none"> <li>• Segregate conflicting traffic from opposite direction by flexible pole barriers</li> <li>• Centre and edge line rumble strips to warn and alert drivers</li> <li>• Proper delineation and warning signs should be provided</li> </ul>
2	Intersections	<ul style="list-style-type: none"> <li>• Mostly unsignalised and uncontrolled</li> <li>• Many are located under the influence area of curve</li> <li>• Restricted sight distance from minor roads</li> <li>• Market areas and high side friction</li> <li>• Undisciplined driving</li> <li>• Illegal vehicle parking and auto stands restricting view</li> </ul>	<ul style="list-style-type: none"> <li>• Channelize vehicular movements wherever possible</li> <li>• Restrict speed on minor road before merging by speed humps</li> <li>• Corners should be flared for better turning movements</li> <li>• Flexible pole barriers to separate conflicting traffic at major and minor road</li> <li>• Shift bus stops and auto stands to the far side of the intersection</li> <li>• Proper road marking and signs to be provided</li> </ul>

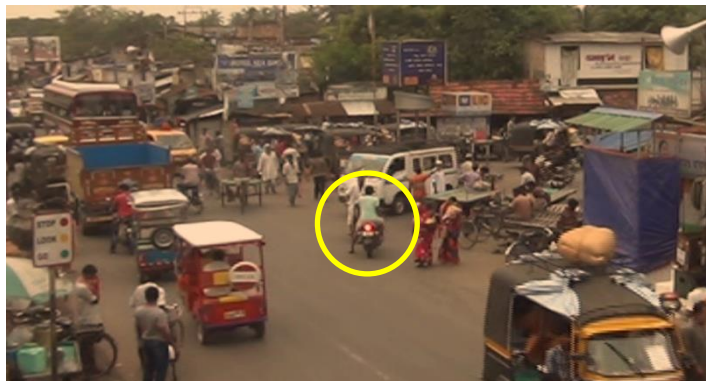
Most of the intersections along the highways were unsignalised and uncontrolled. Several intersections were located on the curve. The approach speed of vehicles from the minor road was high and drivers seldom stopped or reduced their speed before merging with the major road traffic. Moreover, as the opposing traffic were not separated vehicles were found to take wrong turns. During the audit visit the RSA team found several vehicles taking such wrong turns at the intersection posing high danger (Fig. 3). Further, the approach of such intersections was often not visible due to encroachments, therefore the drivers were unable to judge the situation ahead, which resulted in chaotic maneuver. In addition to that the presence of bus stops and auto stands enhanced the problems at the intersections. Such intersection can result in lateral swipes, head on or rear end collisions. In most of the intersections there were no stop line or zebra cross marking and proper signages were also missing.

Fig. 3. Wrong turn by two-wheeler at intersections

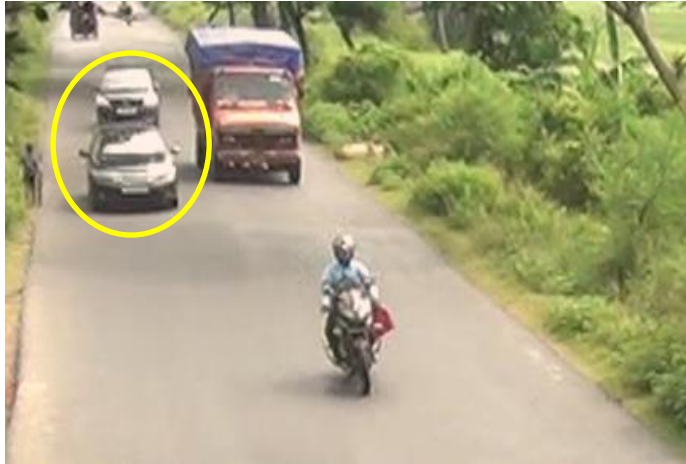
The major safety issue noticed at the straight segments was reckless driving of the vehicles. Since most of the road networks passes through congested locations the drivers generally try to compensate the time travelling at a high speed through the long straight segments. Reckless driving and unruly overtaking (Fig. 4) was very common at these locations. The situation worsened at night when the approach of small streets was hard to notice and unexpectedly pedestrians or NMTs came in the way. Overtaking sight distance was also not adequate along most of the straight segments. There were no speed limits or overtaking prohibition signs to alert the drivers.

Fig. 4. Vehicle overtaking at straight segments

3	Straight Segments	<ul style="list-style-type: none"> <li>• Inadequate Overtaking side distance</li> <li>• Reckless driving</li> </ul>	<ul style="list-style-type: none"> <li>• Centre line rumble strip to alert drivers in monotonous long straight sections</li> <li>• Extra half lane width for passing can be provided at the sections where overtaking sight distance is inadequate</li> <li>• Speed limits and Warning signs for no overtaking zones should be provided</li> </ul>

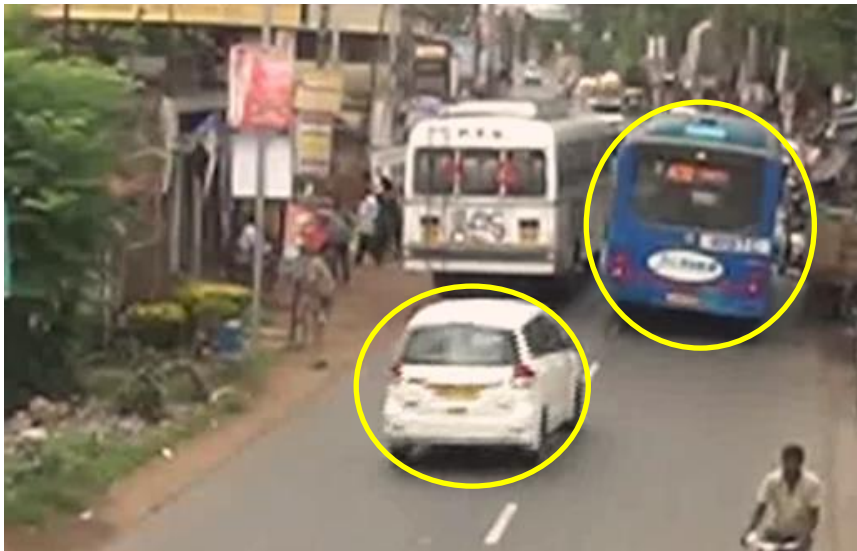
Lack of designated bus bays was a crucial issue for both the highways. The buses stopped anywhere and everywhere to collect passengers. Even pedestrians were found waiting for the buses on the carriageway. It was often observed that cars were trying to overtake the buses from behind without having a clear view of the traffic approaching from the opposite side (Fig. 5). This may result in head on collisions. The situation is more critical near the intersection when the vehicle overtaking a stopped bus could not see the vehicle entering from the minor road at high speed. Even the sudden braking of the bus to collect passengers may result in rear end collisions.

Fig. 5. Overtaking from behind a stopped bus

Sl.	Risk Element	Risk factors	Proposed Countermeasures
1	Bus bays	<ul style="list-style-type: none"> <li>Designated Bus stops are unused/inaccessible</li> <li>Ad hoc Bus stops</li> <li>Bus stops at intersections</li> </ul>	<ul style="list-style-type: none"> <li>Off street bus stops should be provided at specific locations</li> <li>Designated bus stops should be well maintained</li> <li>Shift bus stops at least 100m from intersection area</li> <li>Enforce fines if buses do not stop at designated bus stops</li> </ul>
2	Narrow bridges	<ul style="list-style-type: none"> <li>Sudden reduction in lane width</li> <li>Presence of concrete parapet wall pose as a hazard</li> <li>Vehicles speeding / overtaking near narrow bridge</li> <li>Problem compounded at night due to low visibility</li> </ul>	<ul style="list-style-type: none"> <li>Proper warning signs should be provided before the approach of a narrow bridge</li> <li>The guard rail should be properly embedded in the parapet wall</li> <li>The approach of the narrow bridge should be free from vegetation to provide a clear view of the bridge</li> </ul>

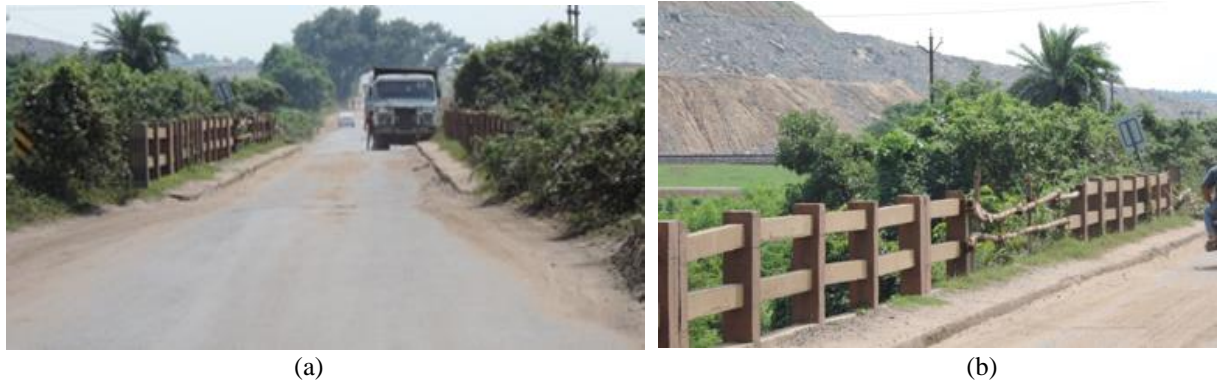
Another safety critical infrastructure identified by the RSA team was the narrow bridges. The number of narrow bridges were higher on NH 60 as compared to NH 117. In most of the cases the approach road to a narrow bridge had no warning signs or speed limits mentioned. In most of the cases the guardrails were broken and covered with dense vegetation (Fig. 6). In few cases the abutments posed as road side hazard. Due to sudden decrease in the lane width the maneuvering at such narrow bridges were found to be dangerous specially at night.

Fig. 6. Safety Issues at Narrow Bridges (a) No proper signages and dense vegetation (b) Broken parapet wall

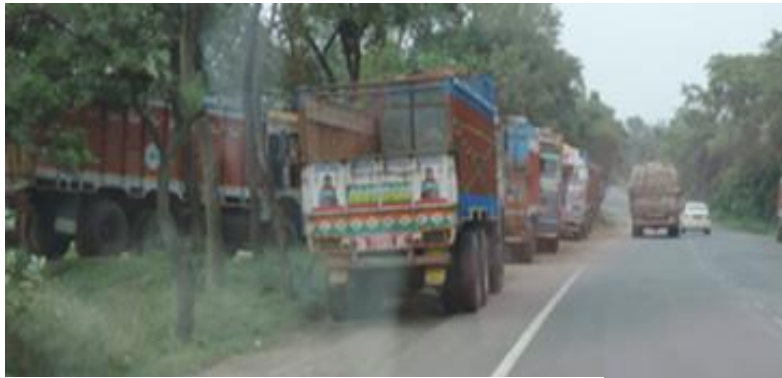
Illegal truck parking was found along long stretches of the highway. The illegal truck parking resulted in edge drop and poor visibility (Fig. 7). Moreover, the effective width of the carriageway decreased. Since large proportion of heavy vehicles plied through these highways provision should be made to construct truck lay bays with necessary facilities. In industrial areas where truck parking is utmost necessary proper paved shoulders should be provided. In addition to that proper information signs to notify the drivers of the truck parking and edge rumble to alert drivers if they are driving off should be provided.

Fig. 7. Illegal Truck Parking along NH 60

3	Illegal Truck Parking	<ul style="list-style-type: none"> <li>Edge drop</li> <li>Restricted vision specially at night</li> </ul>	<ul style="list-style-type: none"> <li>Provide proper truck lay byes</li> <li>Provide wide paved shoulders for truck parking</li> <li>Provide edge rumble strips to alert drivers if they are moving off road</li> </ul>
4	Illumination	<ul style="list-style-type: none"> <li>No/Poor visibility at junctions and built up areas specially at night</li> </ul>	<ul style="list-style-type: none"> <li>High mast illumination should be provided at uncontrolled intersections and built up areas</li> </ul>
5	Pedestrian facility	<ul style="list-style-type: none"> <li>Improper/Inadequate pedestrian facility</li> </ul>	<ul style="list-style-type: none"> <li>Proper maintenance of pedestrian facility</li> <li>Pedestrian facility should be made free from hawkers and encroachments</li> <li>Proper cross walks should be provided at regular interval</li> <li>Speed tables should be provided near hospital and schools to reduce speed on major</li> <li>Simple ITS solutions can be applied in areas with high access density</li> </ul>

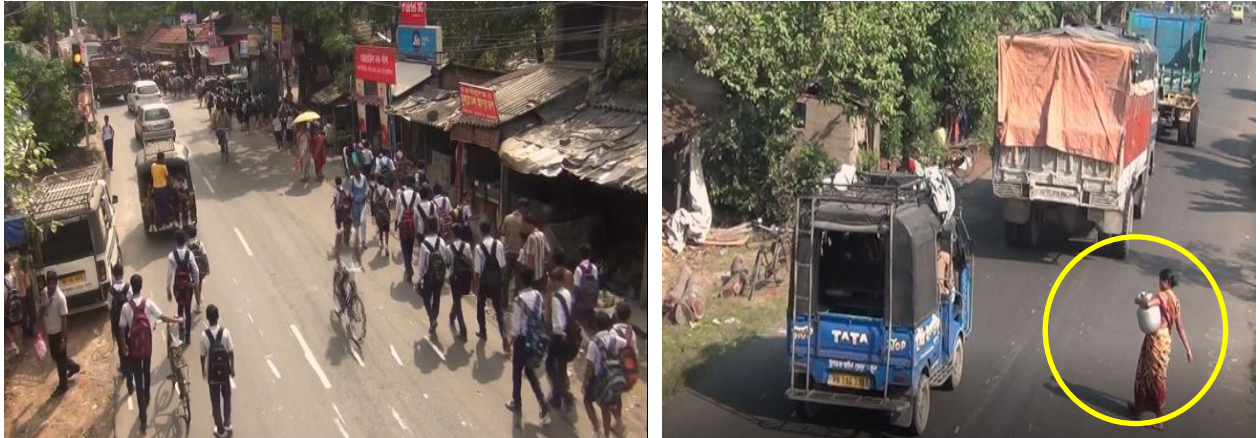
Although numerous market areas, schools, colleges, offices and hospitals were noticed along the road sides and high amount of pedestrian volume was found at these locations the basic pedestrian facilities were missing in most of the locations (Fig. 8). *Although a few locations were provided with pedestrian sidewalks they were occupied by*

hawkers and illegally parked two wheelers and bicycles. As a result, pedestrians preferred to walk on the carriageway instead. None of the intersections had proper cross walk facility and pedestrians *were found* crossing the road at any point. In few places such as near schools or markets, pedestrians were found to occupy almost half of the carriageway. In general highways are built for higher mobility and lesser accessibility, but in case of such highways which runs through important towns and have considerable built up area all along providing proper access to the highway is a necessity.

Fig. 8. Lack of Pedestrian facility (a) School children walking on the carriageway (b) Pedestrian crossing the road carelessly

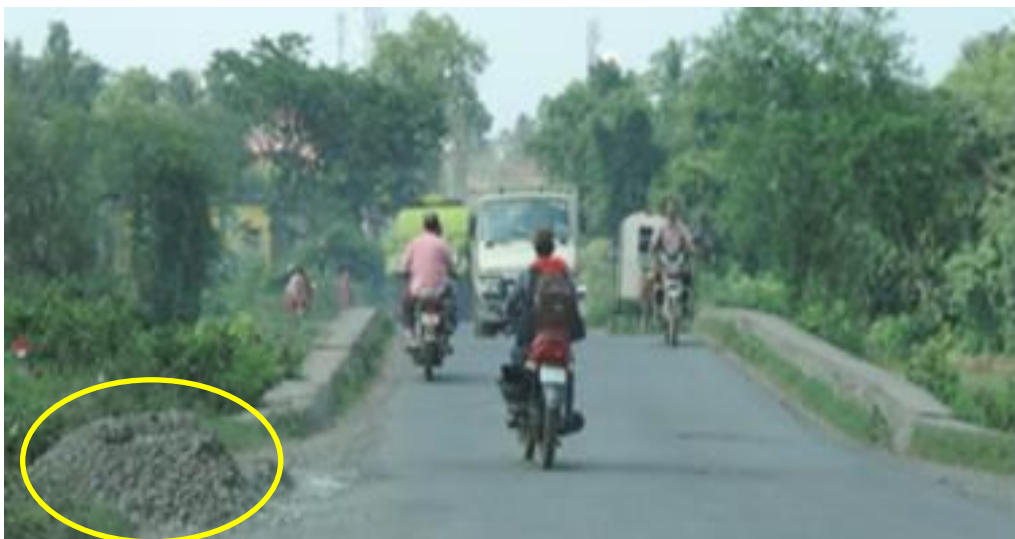
Dumped construction material were found at several places along the road stretch. The effective width of the carriageway decreased with such stocked material on the carriageway (Fig. 9). Moreover, it posed hazard to NMTs and Pedestrians as they may skid while speeding or giving pass to other vehicles.

Fig. 9. Stocked Material near approach of narrow bridge

6	Dumped construction material	<ul style="list-style-type: none"> <li>Dumping of construction material on shoulder and carriageway</li> </ul>	<ul style="list-style-type: none"> <li>Dumping of construction material on the side of the highway should be prohibited and local authorities and police should enforce fines for such activities</li> </ul>

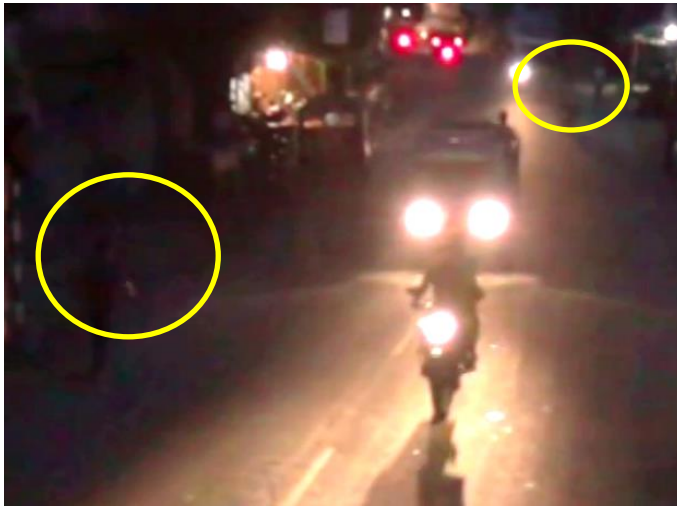
NMTs were also present in high proportion on both the highways. School children on NMTs were the riskiest road users as they had less judgement of vehicle speed and were often found to travel in a group blocking almost a lane of the highway. In some cases, it was observed that the NMTs were heavy loaded and were unstable. During the night time it was very difficult to spot NMTs along the road especially near intersections or curves where they generally slowed down for taking turn (Fig. 10). NMTs should not be allowed on highways without retro reflective stickers on them. Provisions should be made for bike lanes on both sides for safe movement of students.

Fig. 10. Poor visibility of Pedestrian and NMTs at night

Sl.	Risk Element	Risk factors	Proposed Countermeasures
1	Pedestrians	<ul style="list-style-type: none"> <li>• Risky crossing of roads</li> <li>• High pedestrian volume at market areas</li> </ul>	<ul style="list-style-type: none"> <li>• Separate pedestrians from high speed traffic by providing pedestrian guard rails at risky areas</li> <li>• Speed limits of vehicles should be restricted to maximum of 40km/h near market and built up areas</li> </ul>
2	NMTS	<ul style="list-style-type: none"> <li>• Unsafe crossing and merging maneuvering</li> </ul>	<ul style="list-style-type: none"> <li>• Wide paved shoulders should be provided where the volume of non-motorized traffic is high and especially near markets and school areas.</li> <li>• NMTs at night should have retro reflective stickers in their vehicle so that they are spotted well in advance</li> <li>• Safety edge should be provided at the sections with high edge drop so that it is easy for the NMTs to mount.</li> </ul>

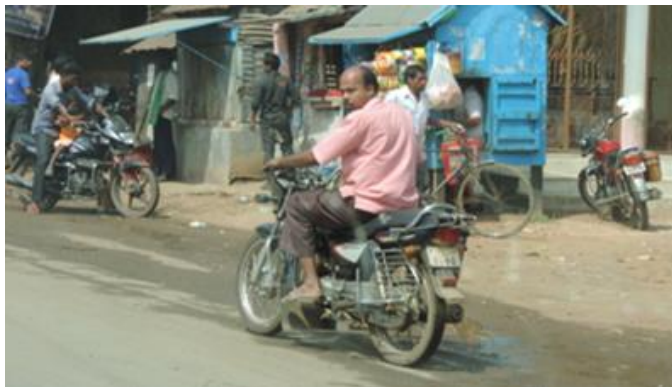
Fig. 11. Two-wheeler rider without helmet

A common observation was made by the audit team that most of the drivers were unaware of the safety aspects of driving. Most of the two-wheeler riders drove impudently along the highway without wearing helmets (Fig. 11).

3	Other vehicle drivers	<ul style="list-style-type: none"> <li>• Reckless overtaking</li> <li>• Speeding at built up area</li> <li>• Not following traffic rules</li> </ul>	<ul style="list-style-type: none"> <li>• Strong enforcement by local police authority</li> <li>• Awareness for road safety should be spread among the local people and they should be educated to abide by safety rules</li> </ul>
