ADEQUACY OF OPERATION AND DELAYS AT SIGNAL CONTROLLED CROSSINGS WITH AND WITHOUT PEDESTRIAN DETECTION

PARKIN, John, University of Bolton, j.parkin@bolton.ac.uk

WILSON, Robert, Lancashire County Council, rob.wilson@lancashire.gov.uk

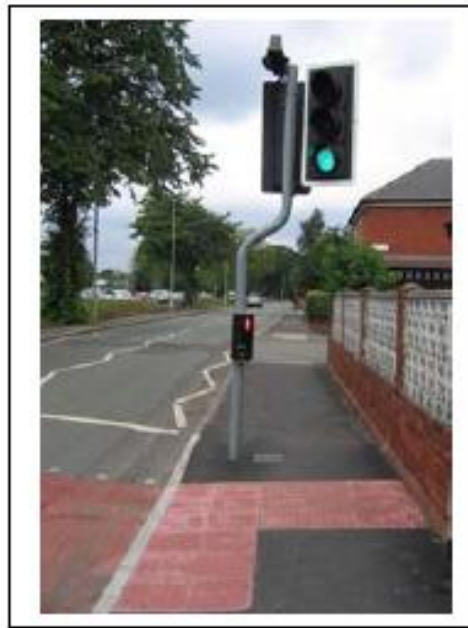
Figure 1 Puffin Type Control showing overhead detectors and nearside pedestrian signal

The Red and Green Figure aspects are signalled to pedestrians by a nearside signal head, located such that pedestrians can also watch approaching traffic. The reasons given for near side signal heads are that: they encourage waiting pedestrians to look towards the traffic approaching the crossing; it can be easier for the visually impaired to see; and also it reduces pedestrian confusion when pedestrian signals change whilst they are on the crossing (DfT, 2006).

The nearside signals displayed to pedestrians are similar to those on the Pelican crossing with a Red Figure indicating that pedestrians should not cross and a Green Figure indicating that they may cross (and which is normally accompanied by an audible bleep). There is no flashing Green Figure, because, once the pedestrian is on the crossing, he or she should continue to cross and is unable to see the nearside pedestrian signal head. The sequence is shown in Table 2 (DfT, 1995).
